**Wind Farm Foundation Assessment  
Corneen, Ballyconnell, County Cavan, Ireland  
Airtricity**

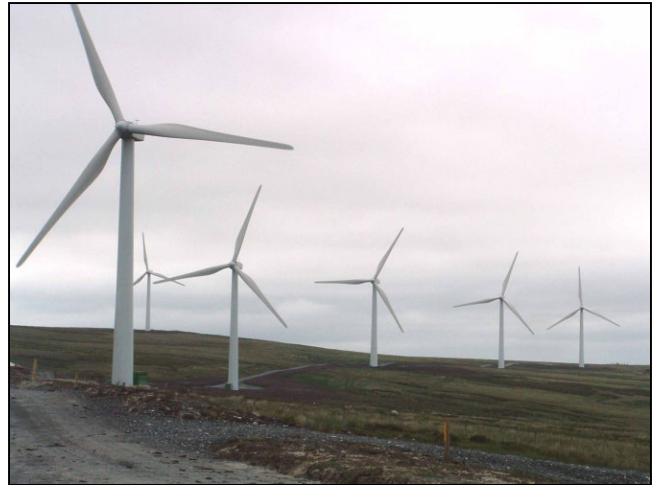
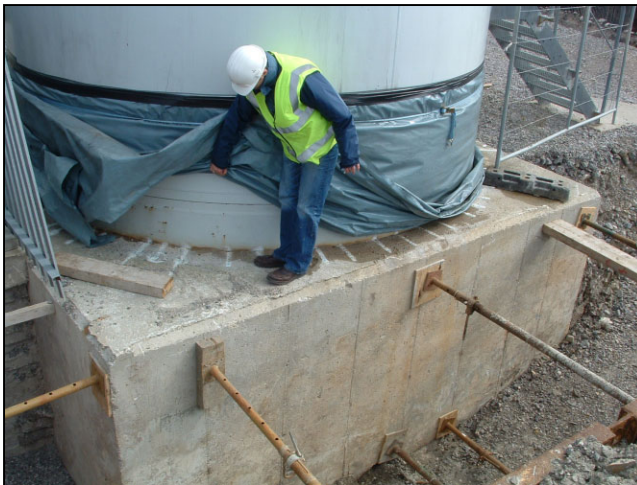
Collins outsourced the investigative work, which used hydro demolition techniques to remove concrete and expose the can structure at critical points.

- Collins arranged for the extraction of concrete cores for petrographic examination and identified the failure mechanism.
- To ensure total quality control, Collins observed the reinstatement of areas of the foundation removed and provided guidance to Airtricity.
- Provided construction observation of the remedial work.
