# HIGH MAST LIGHTING TOWER INSPECTIONS REVEAL HAZARDOUS CONDITIONS

## COLLINS ENGINEERS INC.

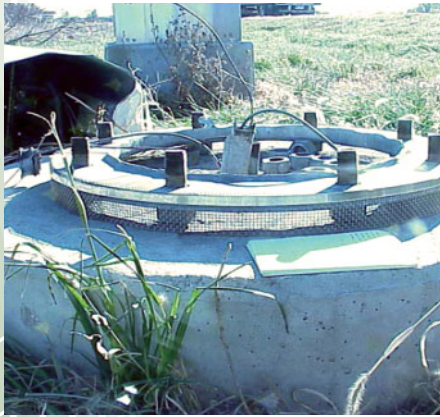
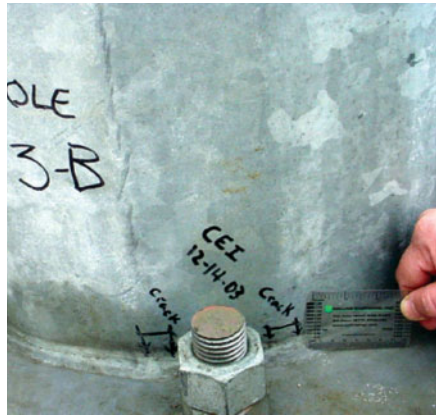
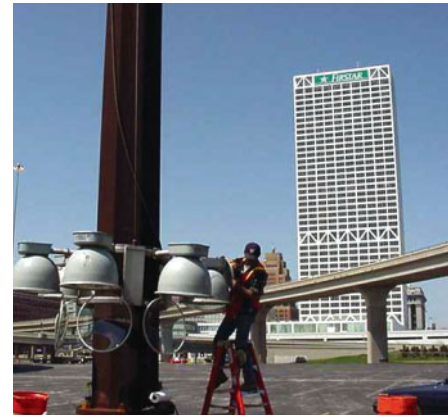
**BACKGROUND:** On November 12, 2003, a 140-foot high mast lighting tower collapsed near Sioux City, Iowa, during a windstorm. At the time of collapse, wind speeds were reported at 37 mph with gusts up to 56 mph. The collapsed high mast lighting tower was a 12-sided, galvanized steel shell, attached to the base by a socket type connection. The socket connection fit the tower shell into a hole in the base plate. Two circumferential fillet welds connected the tower shell to the plate. One weld was on the top of the base plate, and the other between the end of the shell and the side of the hole in the plate. The fracture occurred in the shell at the upper toe of the top fillet weld. After further investigation, cracks were found at each of the 12 bend points on the top circumferential fillet weld of the tower shell. During the windstorm, the entire cross section fractured causing the high mast lighting tower to fall.

The Iowa Department of Transportation (DOT) recently removed 19 cracked high mast lighting towers from service after one high mast lighting tower fell due to a crack near the base plate weld. In order to ensure the safety of the public, the Iowa DOT contacted Collins Engineers, Inc. to perform a comprehensive inspection of 226 structures before Christmas and the winter snowstorms. Within one day, Collins submitted a customized inspection plan, written procedures for nondestructive testing (NDT), a staffing schedule, and cost-conscious options to complete this massive task in a very short time frame.

There were a total of 20 galvanized high mast lighting towers of similar construction and age located in Sioux City. These high mast lighting towers were erected in 2000 or later. Twelve out of the 20 towers exhibited significant cracking in the same location as the tower that failed. As a precautionary measure, the DOT decided to take down all 20 towers.
